GEM HSSE Communication

Small Explosion Near Miss

Incident: Near Miss
Location of Incident: Missouri
Date of Incident: February 26, 2004
Time of the Incident: 10:00 am

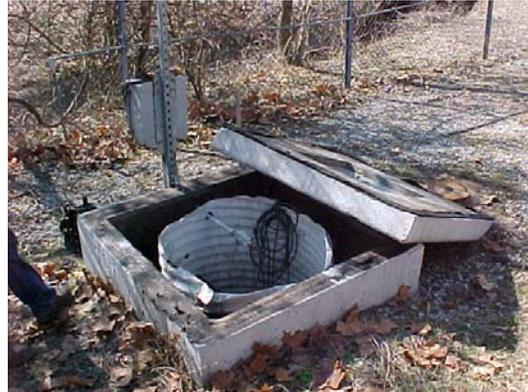
During routine daily inspections, it was discovered that the concrete cover to the sump vault had been displaced and was laying upside down beside the vault. Apparently, a spark had ignited vapors within the enclosure, causing a small explosion that had displaced the lid. No one was injured, and there were no signs of a fire associated with this incident.

Each time the pump started, the small torque caused the electric wire to rub against the steel cable suspending the pump. This eventually exposed the wire.

Photo showing displaced sump cover.

1. Implemented a procedure requiring power to be disconnected during inspections of the sump interior, so possible injuries due to sparking during inspection will be eliminated.
2. Implemented a procedure to regularly inspect equipment and power cables.
3. Changed placement of pump and cables, and replaced power cable with more abrasion resistant material.
