BP Safety Communication Incident Report

LOCATION OF INCIDENT: Blend Plant Gent

DATE / TIME OF INCIDENT: 15th November 2010 0930 hrs

TRACTION # : 2010-IR-3690894

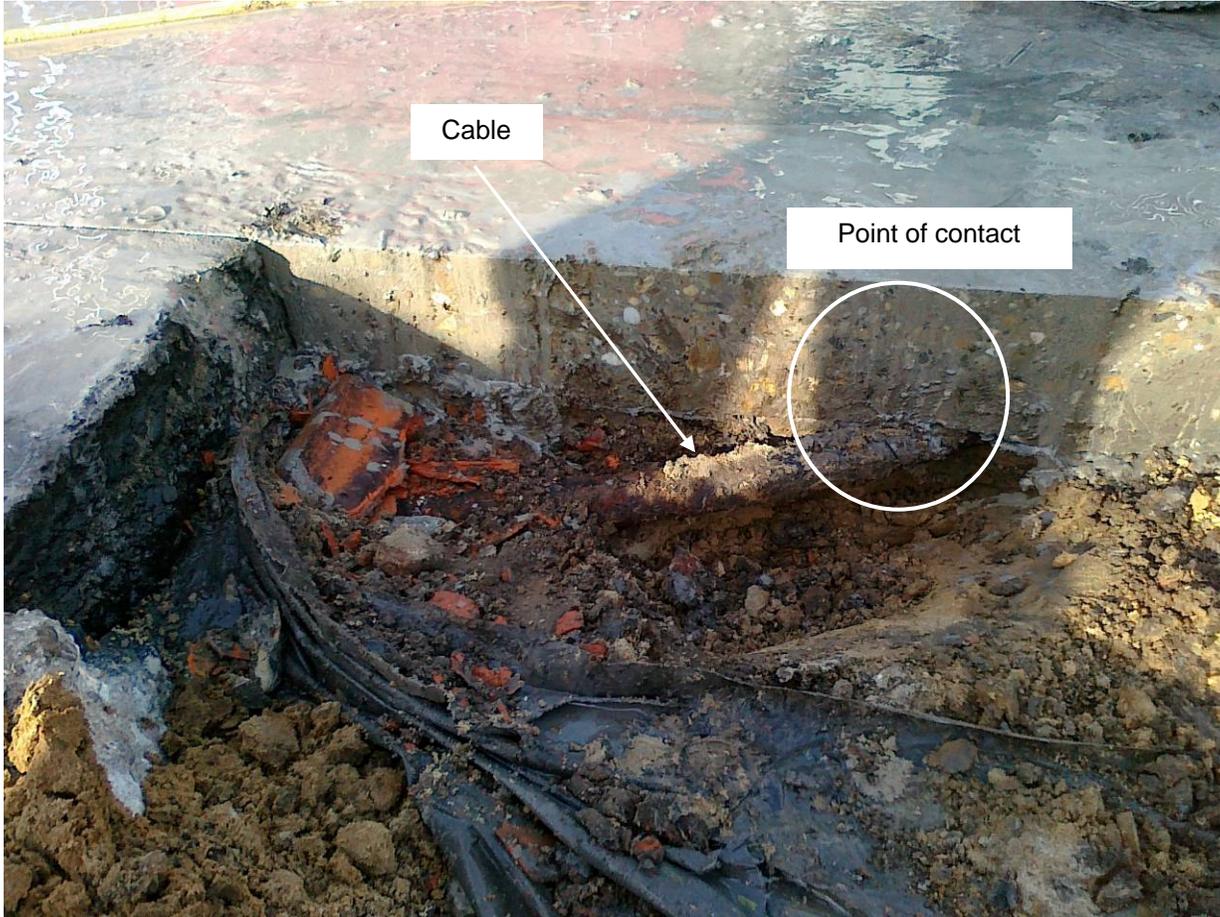
1. The 12kV cable was laid at a depth of 17cm at the point where it diverted out from the cable trench which allowed it to be cut by the concrete cutting disc, set at 20cm. The cable had not been laid in compliance with the relevant depth standard in force at the time the cable was laid (min 60cm).

Point where cable was contacted by cutting disc showing cable sandwiched between concrete and soil at 17cm deep – not buried in soil at minimum of 60cm.

Identify if any other similar situations exist on site, i.e. where there is evidence or knowledge of buried cables, gas lines, etc but their exact location is not clear. Investigate potential for identifying exact locations using best available technology (e.g. ground scanning) and include relevant information on site drawings. Mark areas so that it is clear to observers that there are buried high risk utilities in those locations. The scanning will include ground and walls to determine presence of cables, pipes etc.

Review local ground disturbance procedure to ensure the mandated use of best technological possibilities (e.g. ground scanning) for the accurate tracing of utilities.
