OneWhiting Tailgate Discussion

WEEK OF 09/20/2010

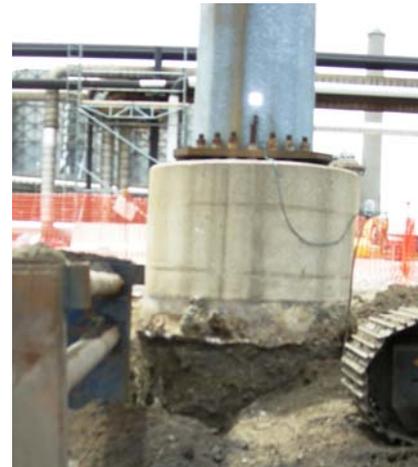
(Cherry Point Refinery) On February 17, 2010, excavations for the Sour Water Project were underway in the vicinity of two operating VFD (Variable Frequency Drives) cabinets. During the excavation, unstable soil shifted from under the VFD cabinets requiring the contractors to stabilize them by tying them off to a beam supported by nearby pipe rack. This was done without advising operations or the AA. Subsequently a unit operator saw the supported cabinets and stopped the work until the situation could be assessed by experts. The situation was found to be stable, but as an extra precaution, two channels were added under the VFD cabinets and the rigging eased to improve the stability.

(Whiting Refinery) On June 9, 2009 a WBU operator was called to site to witness a dead hydrocarbon line hot tapping per the A-7 policy. The operator noticed an excavation located against the foundation of a high voltage line tower. He stopped the job and contacted the Area authority. It was later found that the excavation drawings did not show the foundation and verbal instructions limiting the depth of the excavation against the foundation to 8' were not followed and the excavation had ultimately reached a depth of 12-13'.

- In both instances, the scope of work changed from what was planned but was not properly communicated or re-evaluated for risk.
- In both instances it was an operator performing normal duties who identified the potential issue and STOPPED the WORK.**

- In Whiting, important information and restrictions for work activities were not properly documented in the CoW process.
