REMEDIATION MANAGEMENT HSSE SHARED LEARNING

Fractured Shoulder Blade from Compactor Rollover

Shared Learning: Fractured Shoulder Blade
Business Unit: US Mining, Decommissioning & Alaska Operations
Location: Rico-Argentine Mine Site, Colorado, USA

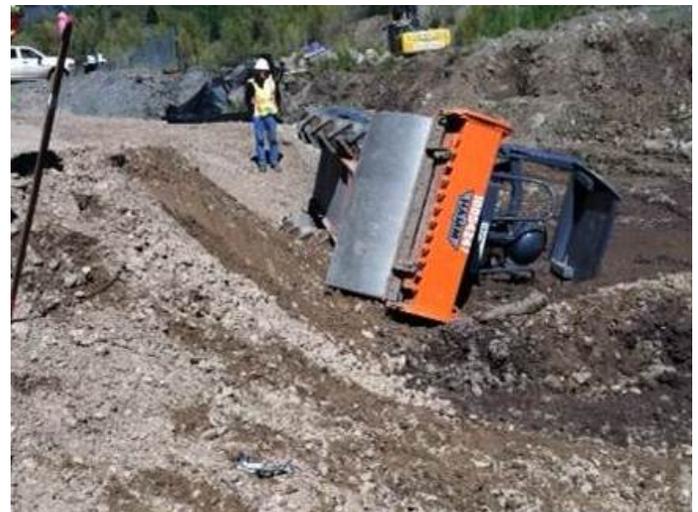
Brief Account of Incident: On September 24, 2013, a subcontractor was compacting a newly constructed oval-shaped berm (approximately 12 feet wide by 4 feet high) with a HAMM 3205 Vibratory Compactor equipped with a smooth roller as part of the Rico Wetlands Demonstration Project. As the subcontractor backed up the compactor around a curve, the rear left tire reached the edge of the berm. While trying to correct, the roller portion of the compactor became extended over the edge resulting in the compactor sliding off of the berm and down the slope. When the compactor contacted the bottom of the berm it rolled over onto its side. The impact caused the IP to sustain a hairline fracture to left shoulder blade.

When the IP operated too close to the edge of the berm while moving in reverse, the compactor slid off the berm and rolled on its side at the bottom of the slope. Neither the IP's co-workers, supervisor nor project oversight stopped work when they observed

Construction activities should be thoroughly risk assessed, mitigations cascaded to the work force through effective TSEAs or other field task work assessments.

Confirm Competency of Subcontractor Equipment Operators.

Confirm Oversight personnel are competent and understand project risks. Also, ensure oversight personnel accountabilities are clear and understood by the workforce.

Reaffirm Stop Work authority and expectations with entire work force (especially for subcontractors) prior to work execution and continuously reinforce throughout project.
