# REMEDIATION MANAGEMENT INTEGRITY MANAGEMENT COMMUNICATION

## Lessons Learned One-Pager

**Type of Incident:** Near Miss - IM Related  
**Business Unit:** Remediation Management  
**Location of Incident:** Cupertino, CA (#495)  
**Date/Time:** November 12, 2008 at 13:30

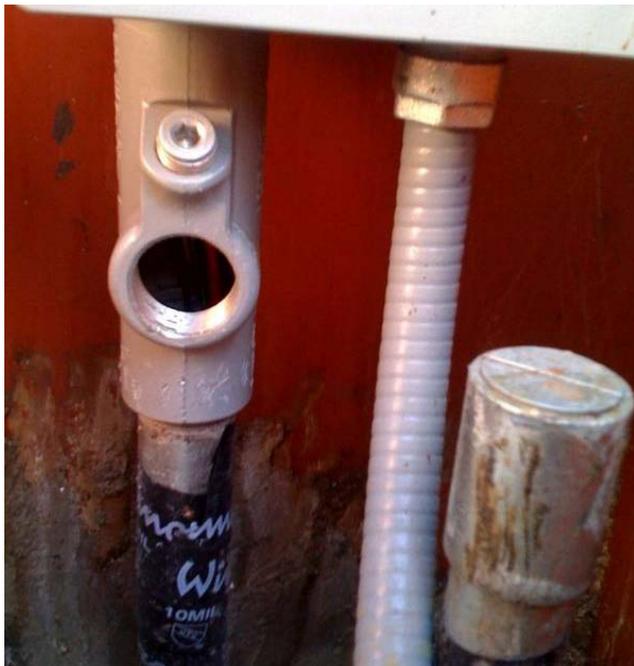
**Detailed Description:** A more detailed investigation was carried out. The Dual Phase Extraction system consists of an SVE system plus groundwater pumping with an electric pump. There are several possible explanations for the sequence of events that led to the high hydrocarbon concentration at the panel. However, what is not in doubt is that: 1) The electrical conduit running from the pump to the control panel provided the pathway for the hydrocarbon to reach the panel, and 2) The conduit contained seal-offs (also called seal fittings or EYS fittings) which had not been filled with sealing material.

The picture above shows an example of an open, unfilled seal-off in a well vault.

**Risk Assessment and Mitigation:** Electric conduit has a small diameter and therefore presents considerable resistance to the flow of large quantities of vapor. This significantly limits the number of scenarios that can lead to a high concentration of hydrocarbon flowing through it and reaching the panel, suggesting that the probability of such

an incident occurring again is very low, even if seal-offs are not filled. If this incident had led to a flash fire, the consequences would likely have been very minor because the amount of vapor present with a high hydrocarbon concentration would have been very small (e.g. the volume of the electrical conduit, and perhaps the panel). There would not have been sufficient fuel present to create a significant risk. Nevertheless, such conditions must be prevented.

An analysis was carried out to determine appropriate mitigations to prevent such a hazard. Although a wide variety of engineered solutions are conceivable, it was concluded that ensuring that the seal-offs are filled is the simplest and most direct approach to avoiding this hazard in the future.

1. Systems containing seal-offs should be checked to ensure that the seal-offs are correctly placed and have been filled.
2. Systems should be evaluated to see if others present a scenario that could lead to a high hydrocarbon concentration in conduit. If there are any systems that present a similar hazard as this incident, and DO NOT contain seal-offs, then the system should be shut down and a hazard review conducted to determine if seal-offs should be retrofitted.
3. For new systems and system retrofits, the requirements regarding seal-offs in the RM IM Engineering Design Manual (see Section 16, Electrical Classification) on the IM website must be followed.

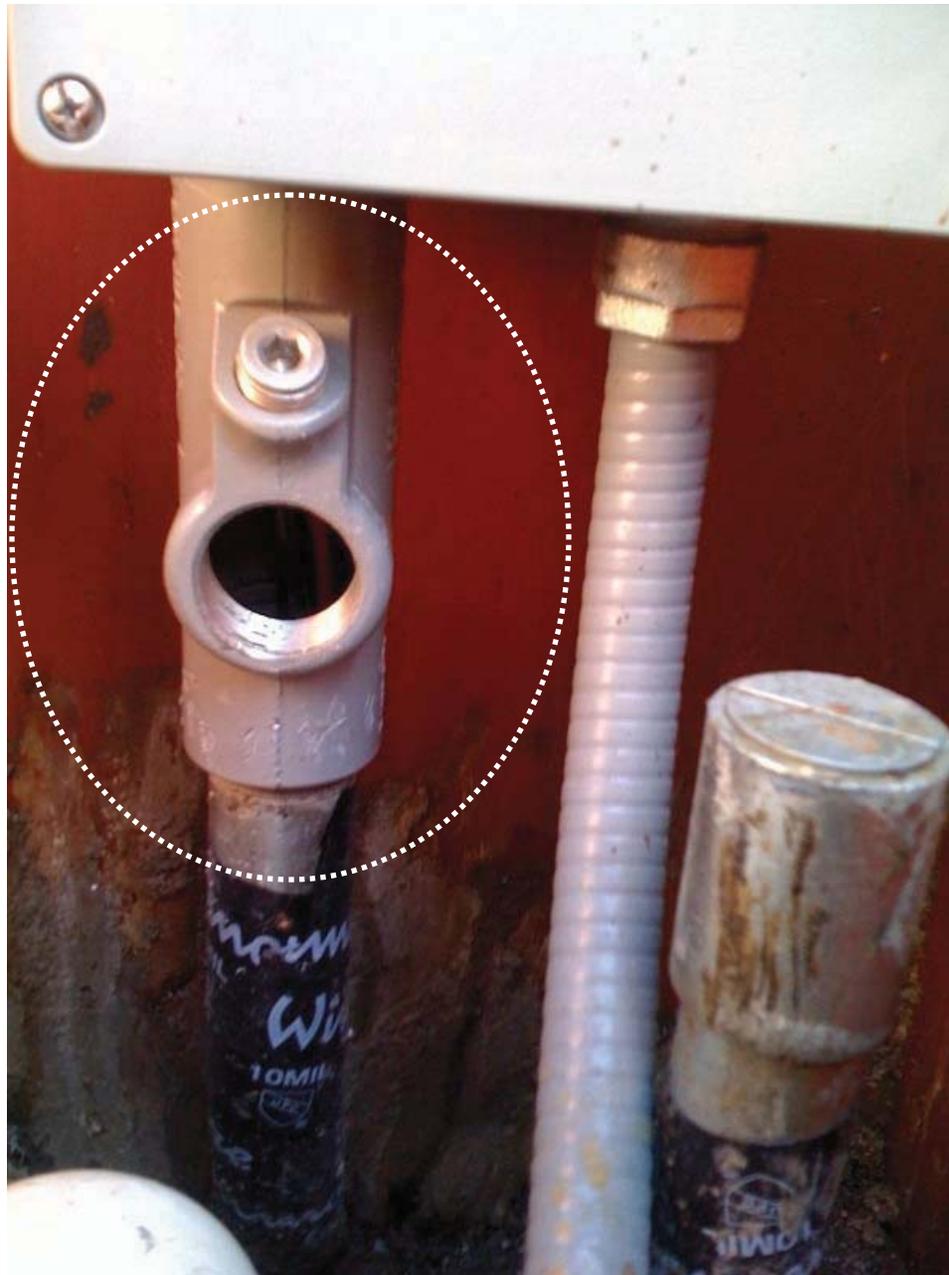
# Close-up of EYS Fitting in Well Vault

EYS Fitting  
(shown  
before adding  
sealant)
