Lessons Learned

Potential Hydraulic Line Break

HSE Observation Summary

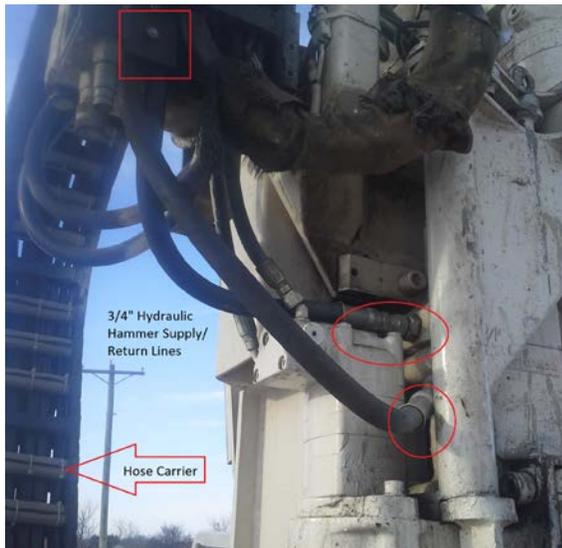
Close-up of the metal clamp that holds the two hydraulic lines that were observed to be worn.

- Vibrations from the hammering caused the metal clamp to wear through the hydraulic hose almost to the point of a hydraulic fluid release.
- The worn hoses were not identified in the daily inspection prior to use.

- Daily equipment inspections must include all areas of hydraulic hose; even underneath the hose carrier clamp.
- Continuous monitoring of equipment during use can identify faulty equipment and trigger a stop work during the task.
- Performing drilling in extremely cold conditions can cause additional wear and tear on equipment.
