Remediation Management Incident Investigation Terms of Reference

HAINAN RD. HIPO INCIDENT DURBIN, SOUTH AFRICA

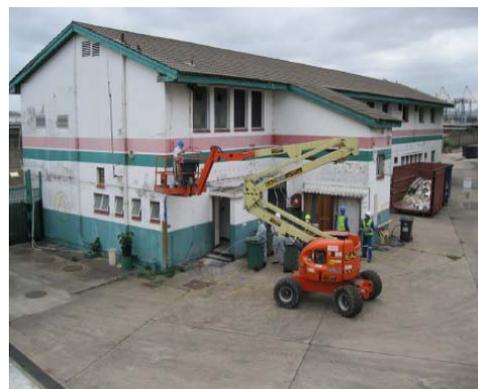
On 28 January 2011 at the Hainan Road demolition project, soft stripping works were performed at an office building as one of three tasks performed on that day on site by RMH, the demolition subcontractor. After internal soft stripping was completed, external soft stripping was started. Workers used a cherry picker to work at height under Working at Heights Permit number WAH 24/01-03.

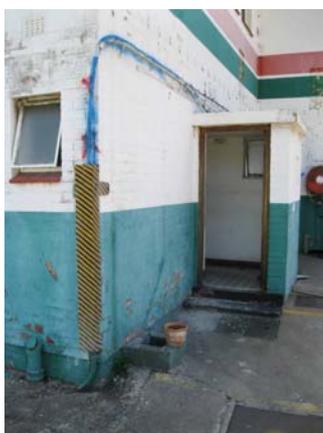
At 13:45 that day, an RMH employee cut through an electrical cable that was present at approximately 2 m above ground level. He reported that he felt a resistance to saw movement and a cramp in his hand, followed by a sudden release. He immediately requested the cherry picker to be lowered.

An investigation of the immediate causes of the accident on the same day revealed that a live power cable (380 V, three-phase) had been cut into. The cable provided the power supply to the office building's distribution board.

Soft stripping was immediately stopped after the incident, and afterwards the affected employee was transferred to the hospital. The cable was traced, identified to have been live prior to the incident, and was subsequently disconnected from the main supply.
