# Concrete Saw Cutting Incident

## Root Root Analysis

Blade Segment Loss – Damage to Station Building

Active Service Station  
Ventura, California

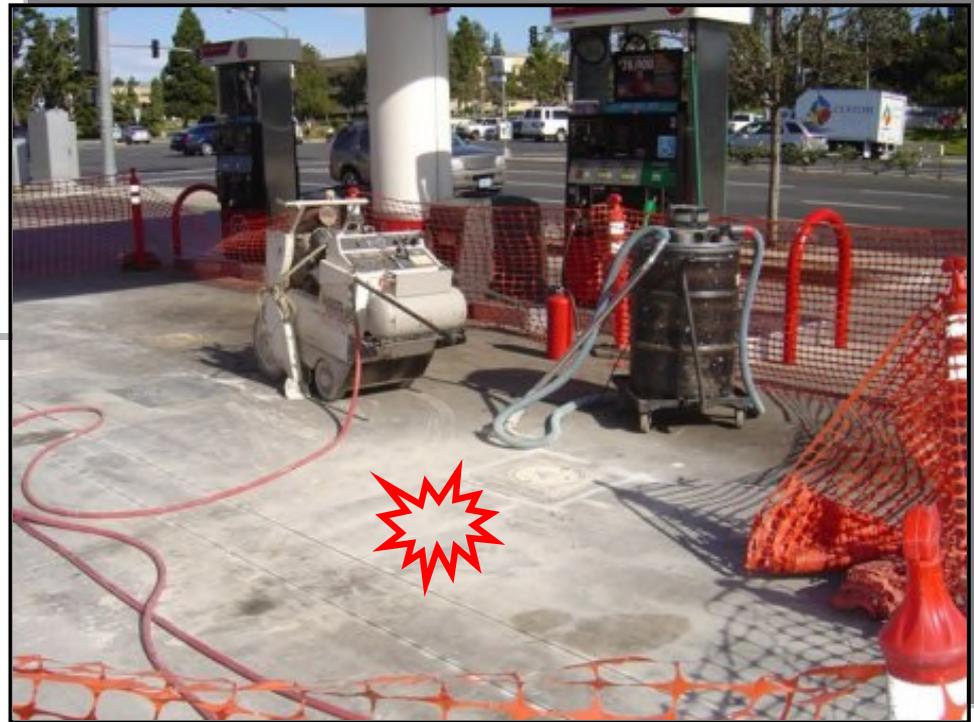
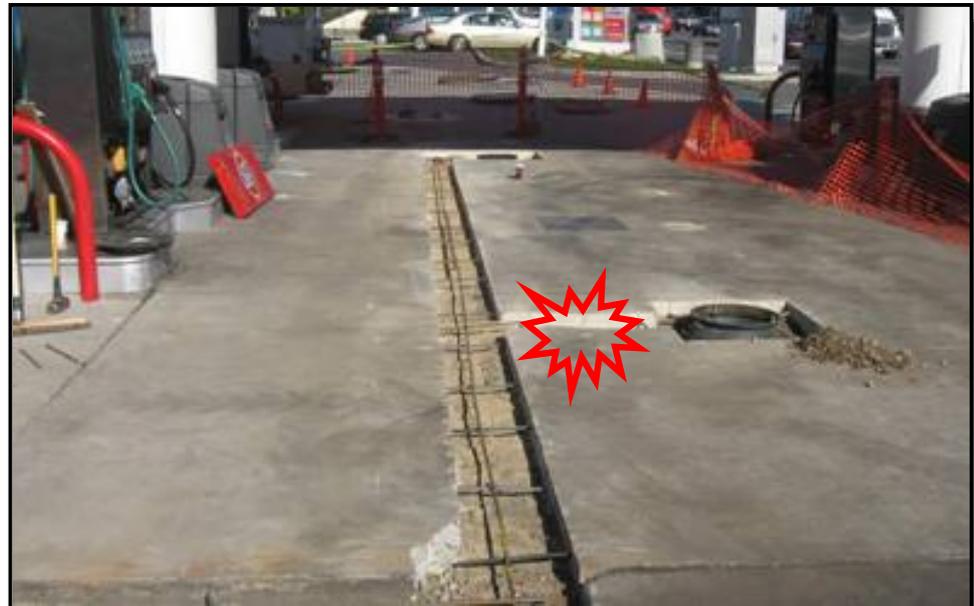
Concrete saw-cutting activities were being performed by the construction contractor on January 20, 2009 near new ozone sparge well CS-12 for trenching (within the exclusion zone between two dispenser islands east of the station building).

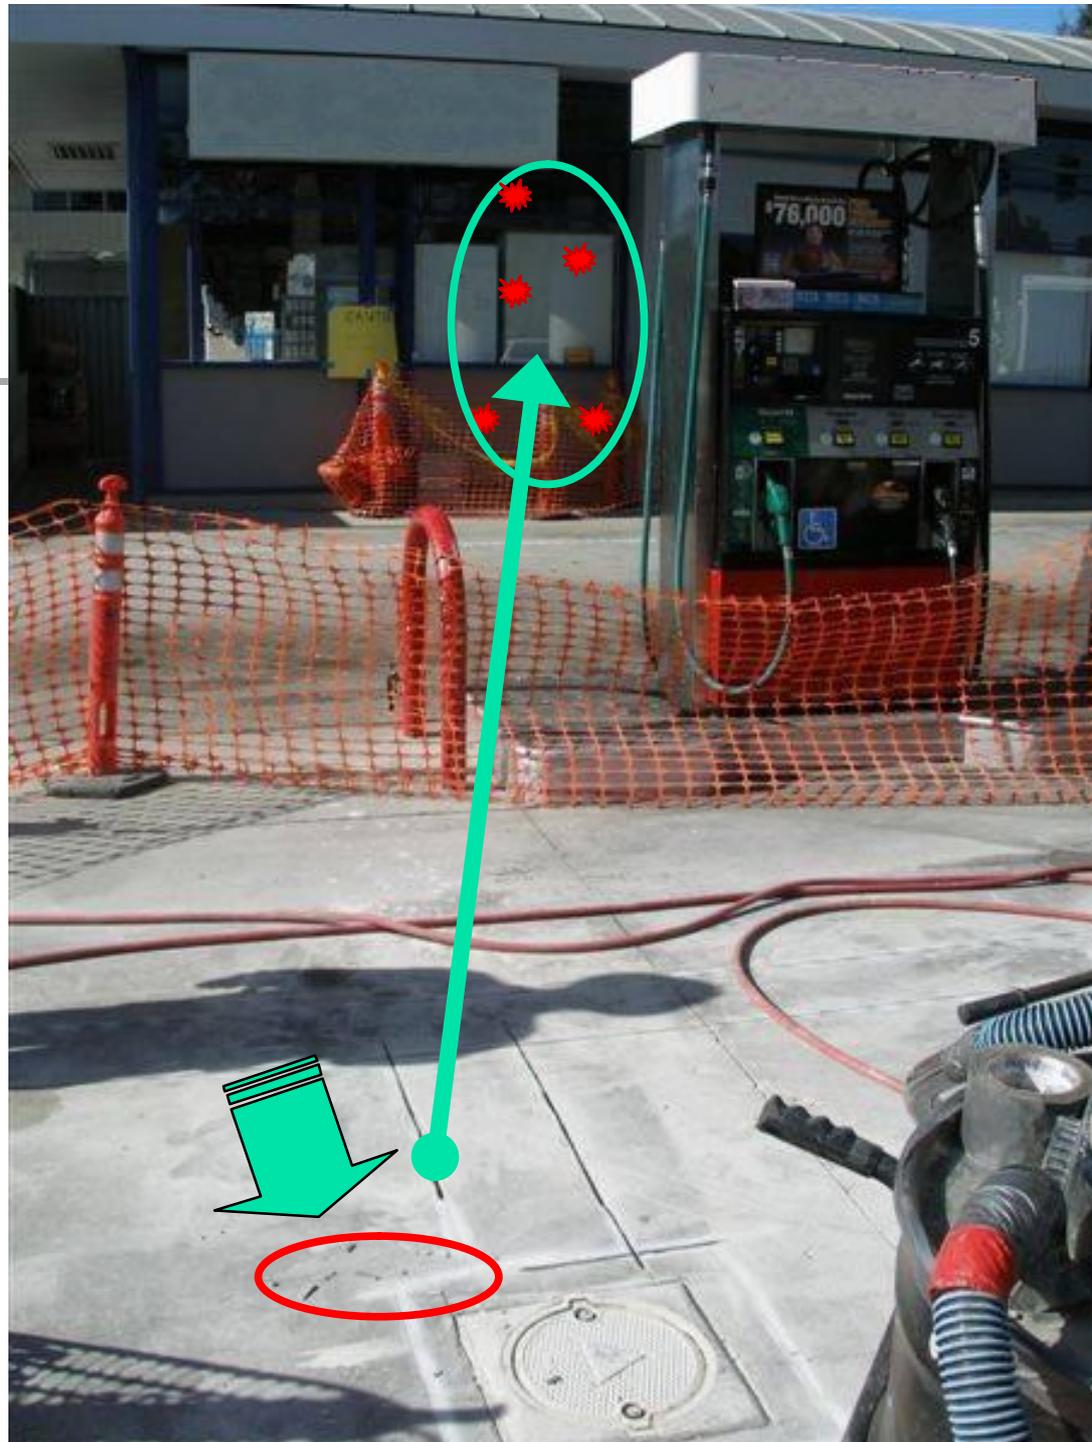
The saw was cutting toward the well box in the foreground and the lost cutting segments were ejected backward at an angle to the cutting plane, and impacted the building's windows in the background.

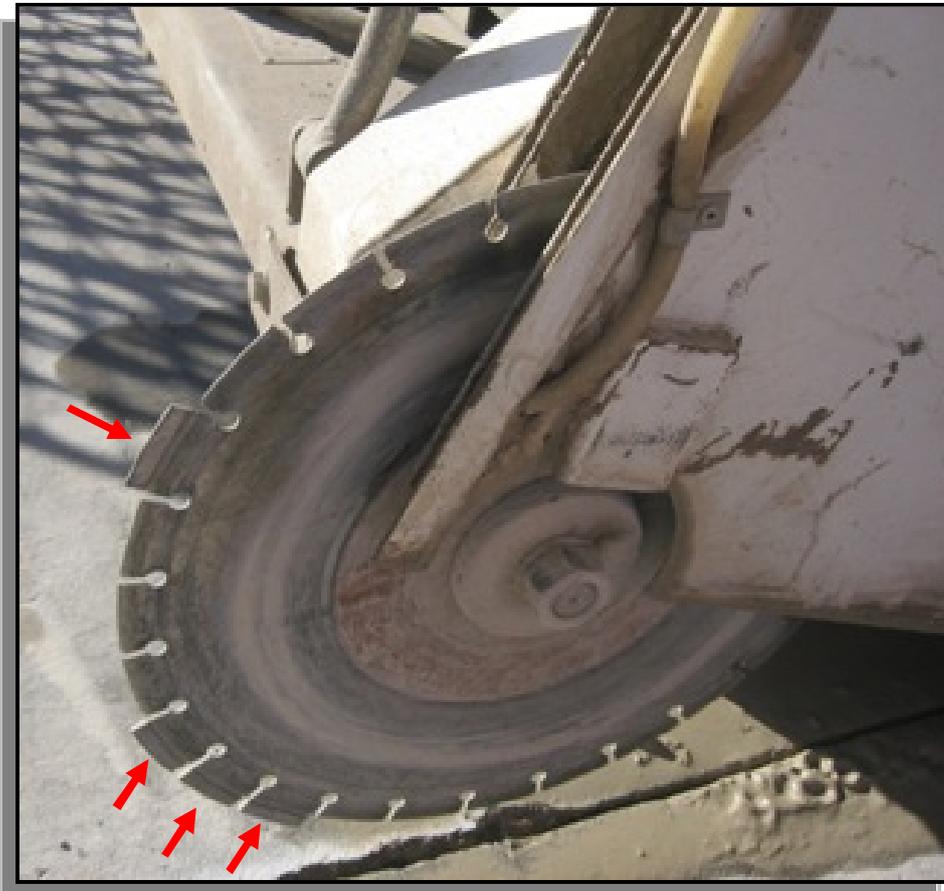
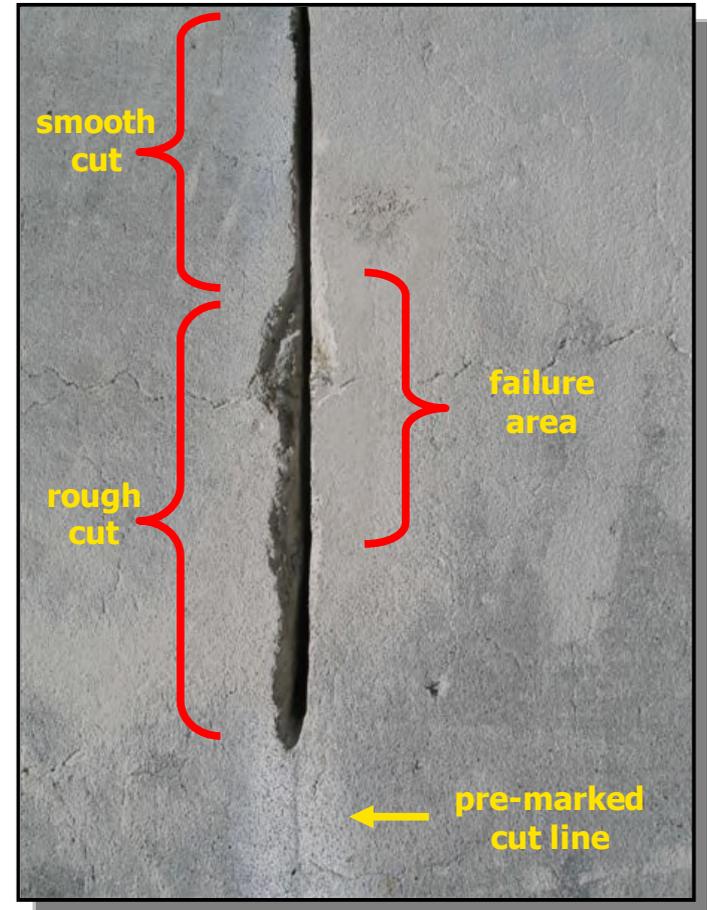
***23 of a total 27 segments broke on the saw blade***

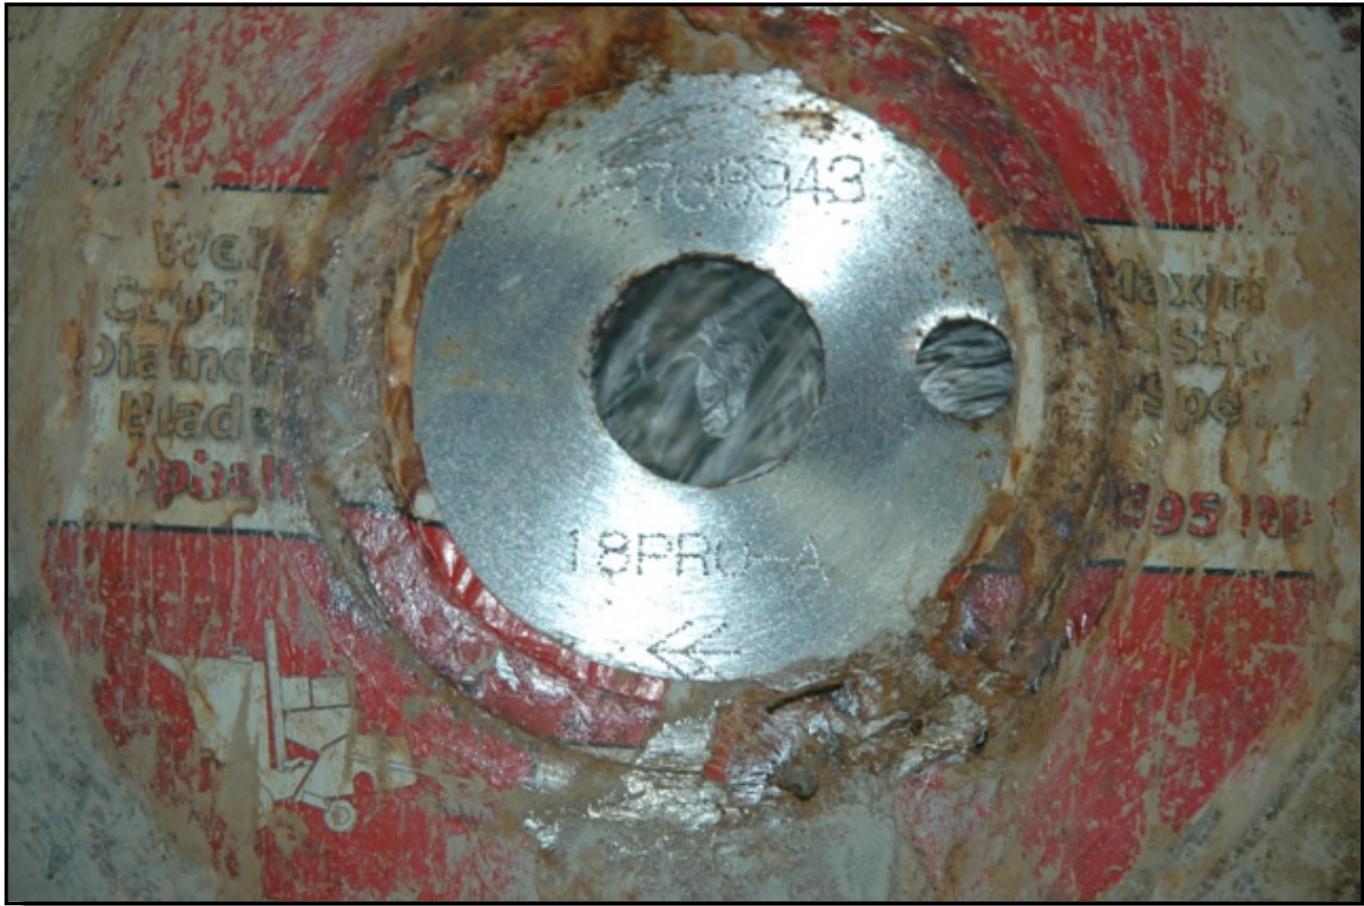
Photograph of saw blade core after Stantec cleaned the saw blade

- Multiquip confirmed that the subject saw blade was a Multiquip manufactured saw blade
  - The 18 PRO-A (ID# 18768943) blade is no longer made but a new model identified as the 18PWBA has the same specifications.

- The blade is designed for cutting asphalt and green concrete
  - The blade is not designed to and is not recommended for cutting cured concrete

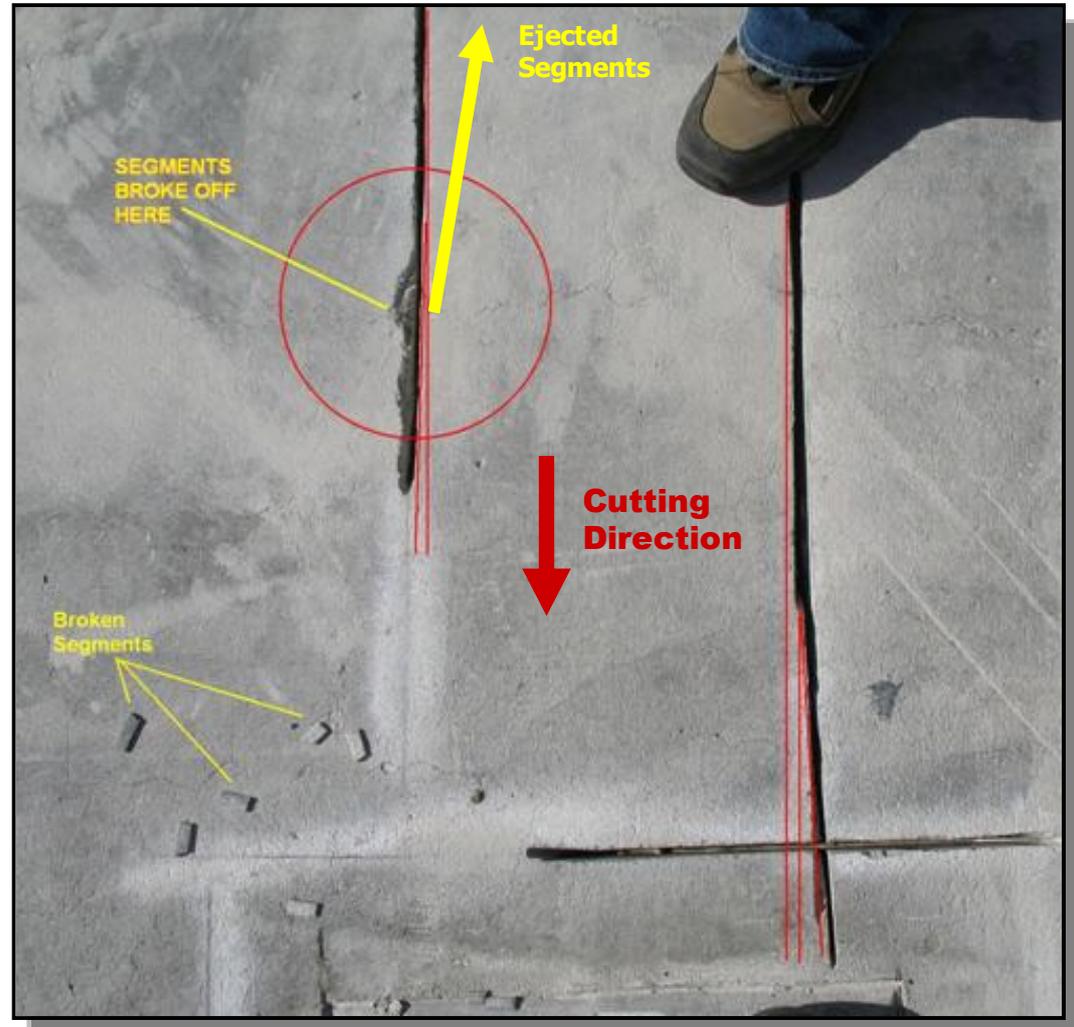
**Saw cut was not completed in a straight line thereby increasing friction and resistance on blade core and segments**

<p>Causal Factor #1 (Procedures / Equipment)</p>	<p>Causal Factor: Saw cut line curving to off line most likely increased friction on saw blade/segments</p> <p><b>Root Cause: Individual Performance/Equipment</b></p> <p>Solutions:</p> <ol style="list-style-type: none"> <li>1. Develop and implement procedures, checklist, SOPs to ensure the saw cuts are completed in straight lines.</li> <li>2. Check procedures for pre-marking saw cut lines, use spotter as necessary to remain on track, use the saw's guide wheel, check that machine is propelled in a straight line, use smaller diameter blade for first shallow cut pass.</li> </ol>
<p>Causal Factor #2 (Procedures)</p>	<p>Causal Factor: Saw operator or the blade may have made a sudden motion when being raised due to initial resistance</p> <p><b>Root Cause: Individual Performance/Procedures</b></p> <p>Solution: Perform saw cutting in slow, smooth, and even motions – <u>back saw out if binding</u> - avoid raising blade.</p>

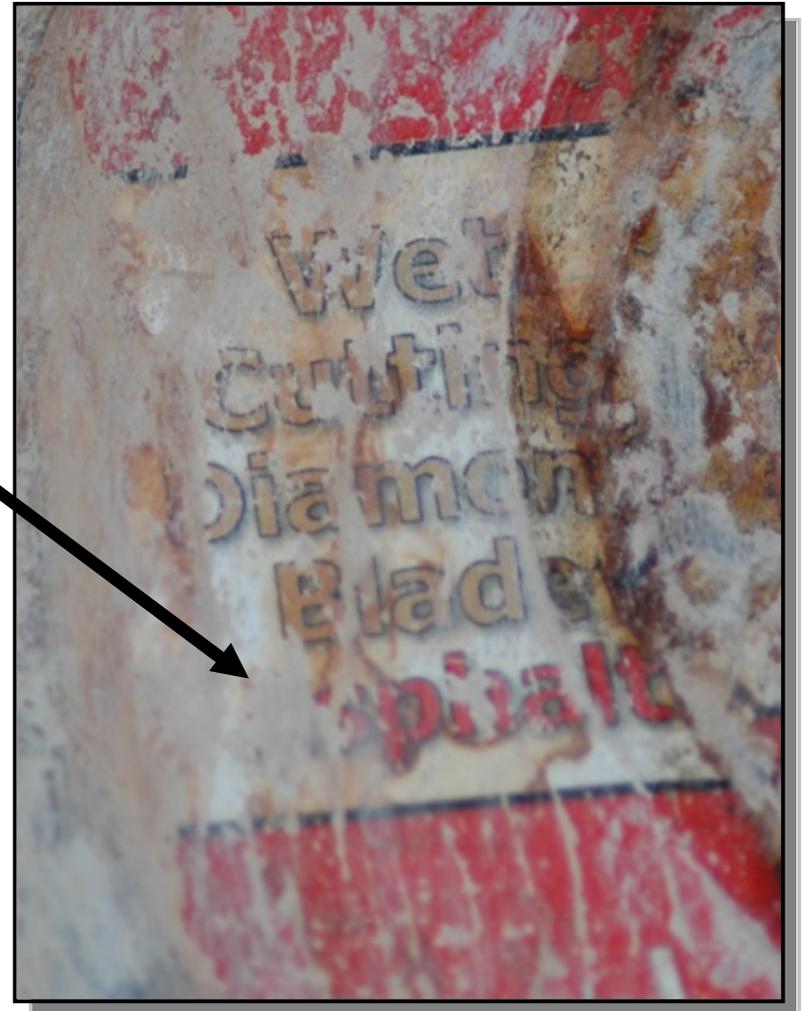
- Material being cut was concrete; saw blade was designed to cut asphalt.
- Incorrect blade could have resulted in excessive wear of diamonds and undercutting of core.

Causal Factor: Use of improper saw blade (blade designed to cut asphalt was used to cut cured concrete)

1. Use saw blade designed for material to be cut.
2. Develop SOP for saw operation that includes selecting appropriate blade type for materials being cut.
3. Implement pre-operation procedures (e.g., checklist, tracking blade type) to verify that the correct blade is used.

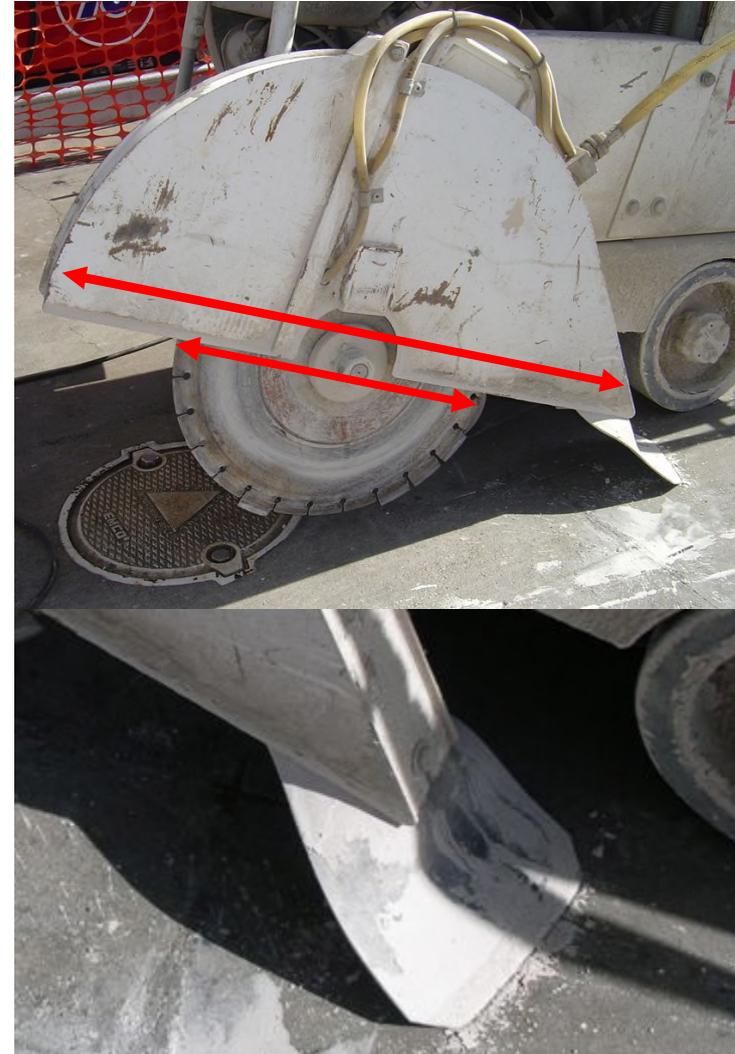
- Different size guards are available based on the blade size. (14", 20", 24", 30"...)
- Some saws have adjustable guards or slip on guards.
- Guard helps keep water in the cutting area for cooling.
- "Mud Flap" at the rear of the guard controls water, slurry, debris from leaving the cutting area.
- Oversize guard may reduce visibility of operator to see the blade.
- Guards should be installed correctly per manufacturer specifications.

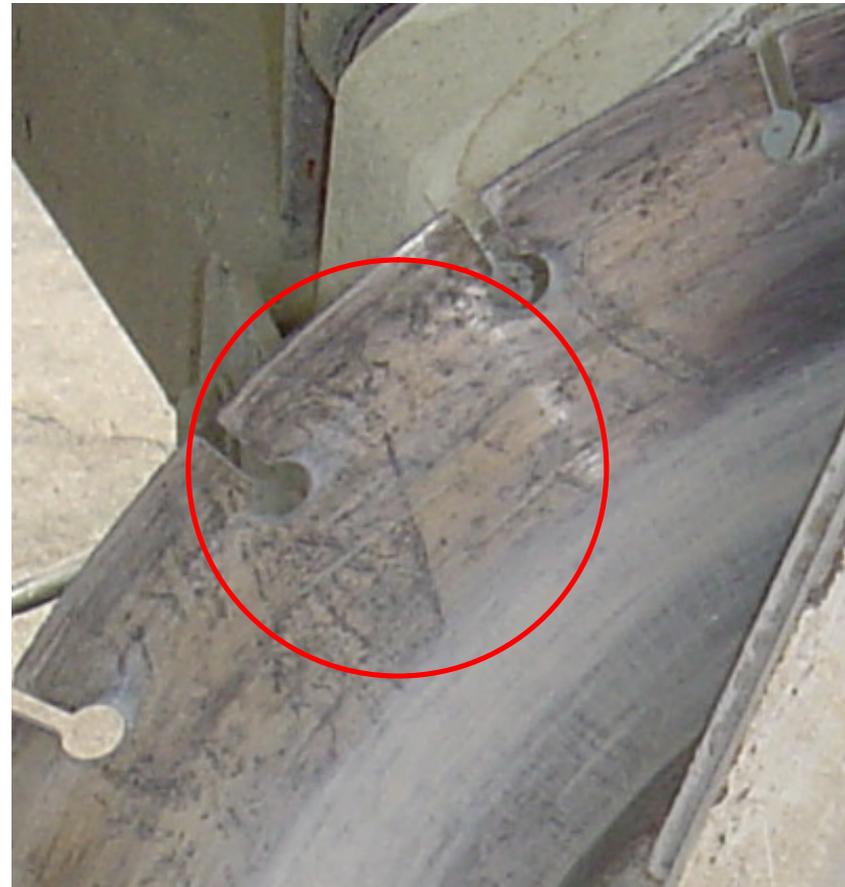
- The segments angle of ejection out of the plane of the saw blade suggest friction or lateral stress on the blade or the segments contacting the edge of the cut.
- Discoloration suggest possible wear from friction on the side of the blade which shouldn't occur when cutting in a straight line.
- The discoloration, possibly from lime or calcium build-up or staining could come from contact with the side of the cut.
