# REMEDIATION MANAGEMENT

## HSSE SHARED LEARNING

### Shoulder Injury from Slip on Slope

**Shared Learning: Shoulder Injury from Slip on Slope**  
**Business Unit: Ops US Other Refining Non Mining E&P**  
**Chemical Lubs**  
**Location of Technology Application: Retail**  
**Stations, Terminals, Bulk Plants, and Refineries**

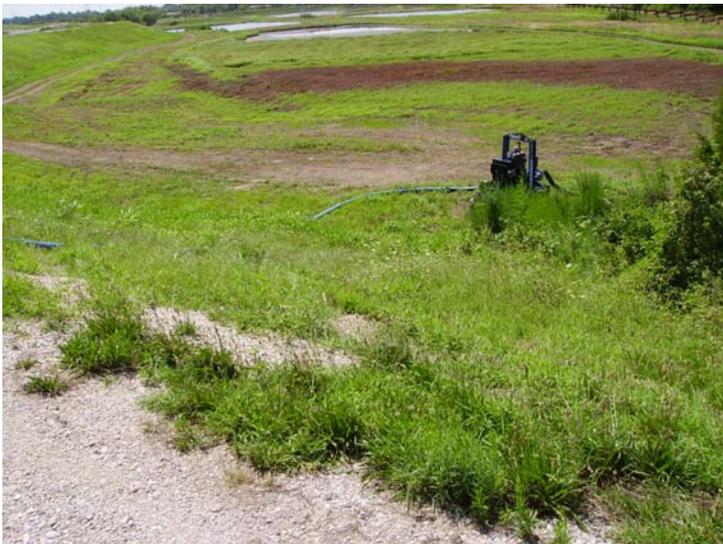
**Slope where injury occurred**

A changed condition (rain caused slippery conditions on a slope) was not recognized and therefore not properly risk assessed, resulting in a slip resulting in an OSHA recordable.

Employee failed to evaluate the risk of traversing on the slope with changed conditions within the assessment tool (WRAT) or TSEA, so proper engineering or administrative control mitigation factors were not identified. The training materials on work risk assessing were not recalled by the employee.

An inventory of sloped areas has been created and an administrative control has been implemented to cease work on slopes. The inventory will be used to identify needs for engineering controls (i.e., stairs, drive paths, etc.) Reinforcement training will be conducted on Work Risk Assessing, focusing on recognizing changing conditions.
