REMEDIATION MANAGEMENT

Lessons Learned One-Pager

Type of Incident: Medical Treatment Shoulder Injury
Business Unit: Remediation Management – US Mining
Location of Incident: Yerington Mine Site, Yerington, NV
Date/Time: October 16, 2013, 08:00 am

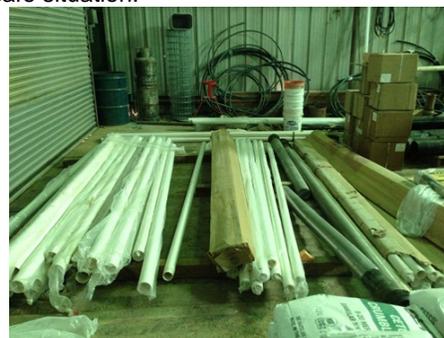
Brief Account of Incident: While walking through a congested work area, a Site O&M Technician tripped and fell to the floor, receiving a contusion and shoulder strain injury. The injured party (IP) was gathering fire extinguishers to bring to a centralized area for annual inspection. One fire extinguisher was located in the corner of a building near the closed roll-up door. When he arrived at the location, he discovered that a drilling subcontractor had recently filled the area with well construction supplies resulting in restricted access to the fire extinguisher. The IP made the decision to attempt to walk across the congested area by stepping on a cardboard box which collapsed or shifted, lost his balance and fell forwards to ground level, striking his shoulder on a nearby steel pipe.

The IP did not use his Stop Work authority to modify his work task when he identified a housekeeping and tripping hazard. Rather than find an alternate safe walking route or delay the task until the area could be cleaned up, he made the decision to walk through an area with insufficient walking surface. Poor housekeeping or staging of supplies was identified as the root cause that created the tripping hazard in the first place. The subcontractor had staged material in a way that did not provide sufficient walking access through the area and blocked access to the fire extinguisher in that part of the building. At the time they were placing materials in this area, access was through the open roll-up door and from their perspective there was not an obvious access issue.

8.1 –Workplace layout/congestion. Materials had recently been stored in this area and designated aisle space was not provided.

22.2 – Development of standards, practices & procedures not effective. Informal procedures had been developed designating areas available for storage of sensitive materials inside the building. Implementation of these procedures was ineffective because the subcontractor had stored some materials inside which could have been stored outside resulting in unnecessary congestion.

22.3 – Communications between different organizations not effective. Specific limitations of material storage requirements (i.e. aisle space, access to fire extinguishers, etc.) were not discussed as part of the procedure. The drilling subcontractor was allowed to stage their supplies with little/no communication with Site field staff.

- A housekeeping plan was immediately implemented and communicated, including developing improved communications methods for establishing subcontractor storage activities at the start of each project and assigning continued monitoring to the Project Field Manager.
- Enhance the safety observation program to complete more frequent safety observations with the goal of coaching workers to improve their recognition of hazards and things they can do to reduce the risks and make safer choices.
- Implement additional safety awareness tools to remind workers of the expectation of their active involvement in the safety program, their responsibility to stop work or make corrections when they see a potentially unsafe situation.
