## Butte Priority Soils Side Dump Rollover

### Investigation Lessons Learned Summary

**Incident:** Side Dump Rollover  
**Type of Incident:** Near Miss/HSE Opportunity  
**Business Unit:** Remediation Management

**Location of Incident:** Butte, Montana USA  
**Tr@ction No:** 2013-IR-4567740  
**Date of Incident:** November 6, 2013

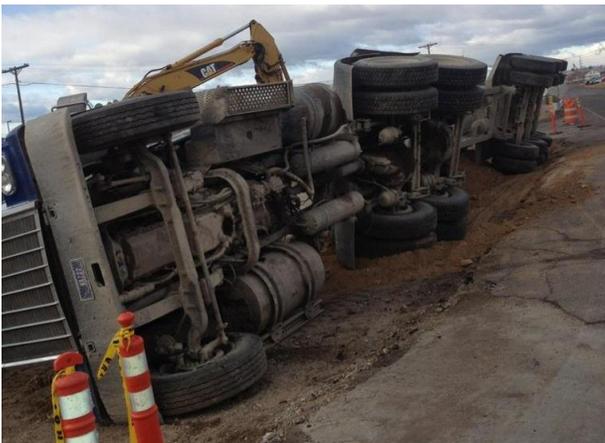
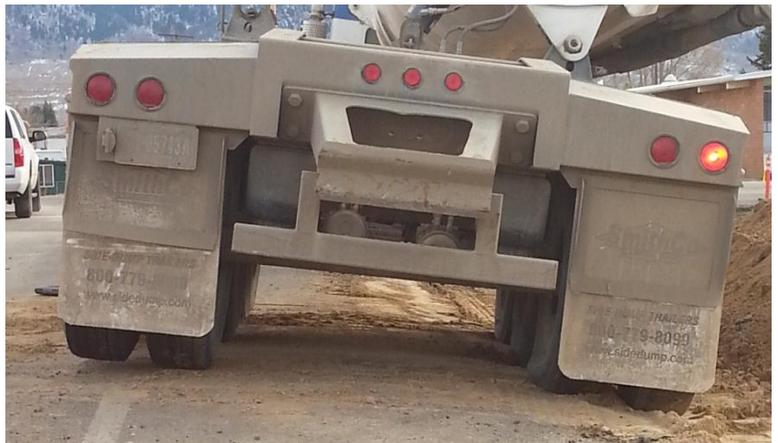
**Brief Account of Incident:** While dumping a load of material, a side dump truck and trailer rolled over onto the passenger side of the equipment. No injuries occurred during the incident. The planned dump site was adjacent to a paved road. Due to limited entry/egress to the site, the first three side dump loads were planned to be dumped from the pavement and used to build an access road into the site where future loads would be dumped. After arriving at the site, the Side Dump Operator (SDO) conferred with the spotter who was also tasked with operating a skid-steer on the site to refine the placement of fill after it was delivered. The SDO then proceeded to drive the passenger side of his tractor-trailer onto the shoulder of the road as the spotter finished moving the traffic cones placed by the edge of the road. This was the SDO's first load of the day, but the second delivered to the site that morning; another SDO had delivered the first load to the site about thirty minutes earlier. As the SDO dumped the load of material, the truck and trailer started to become unstable. The SDO immediately tried to reverse the load and bring the trailer back down; however, the truck and trailer both rolled over onto the passenger side.

**What Went Wrong:** The truck was not positioned with all wheels on the pavement prior to dumping as identified in the pre-job meeting. A communication misinterpretation between the spotter and the SDO contributed to the load being dumped in the incorrect location.

**Lessons Learned:** Guidance and/or procedures for spotter roles and responsibilities did not exist, and therefore were not understood. Communication between the driver and spotter was not effective. Stop work was not employed although questionable conditions were present. Verbal identification and communication of the hazards were performed; however, written documentation was lacking.

**What Improvements Will Be Made:** To ensure dumping from level terrain, the supplier practice for daily toolbox meetings will be modified to include a check of proper vehicle placement for each designated dump site including communication of the dump location and truck position.

Spotter's roles, responsibilities and training will be identified and documented in a new spotting SOP scheduled to be developed and implemented in 1Q2014. Instances when a spotter should be used to mitigate a hazard will be included in the SOP.
