REMEDIATION MANAGEMENT HSSE COMMUNICATION Lessons Learned One-Pager

Type of Incident: Underground cable (22kV) strike
Business Unit: Remediation Management
Location of Incident: Port Hedland, WA, Australia
Date/Time: 8 October 2008, 10:20 am

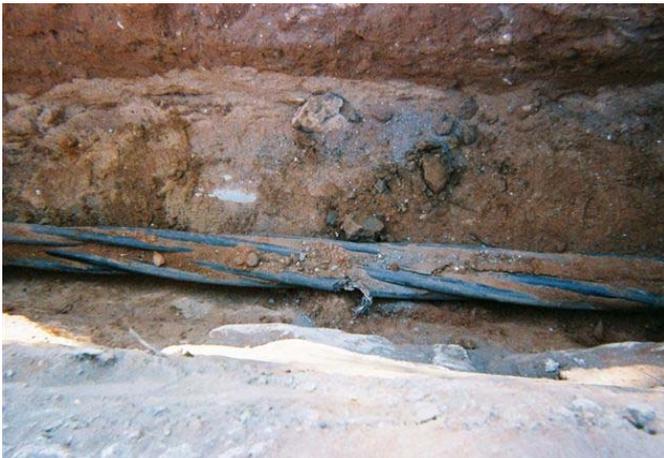
Brief Account of Incident: On 8 Oct 2008, a drilling crew conducting offsite environmental drilling works in Port Hedland, Western Australia, struck an underground high voltage 22kV electrical service at 1.6m depth.

There were no injuries to either the driller or his assistant, who were the only people in the immediate vicinity. At the time of the incident, there were no physical signs that the electrical cable had been struck due to being protected by a highly sensitive circuit breaker, which tripped immediately when the conduit was struck, and prior to the augers contacting the cable. Adjacent businesses who had lost electrical services, first notified the drillers of the incident, at which time work was immediately ceased.

Actual Outcome: Electricity to the area was restored within two hours and Horizon Power advised that a single phase from one of two high voltage cables was struck, causing physical damage to the cable. The damaged cable was permanently repaired the following day.

- Underground electrical cables shown on plans were not located by a professional cable locator;
- Unaware the cable was installed by directional drilling, when shallow natural soils were encountered, it was assumed no services could exist below;
- When not located, liaison with the local power authority asset owner for confirmation was not undertaken;
- A single phase from a high voltage cable was damaged and power to a number of customers was interrupted.

4.6 Routine Activity without Thought: After successfully locating numerous services in other areas, at this location the cable locator made assumptions on the service location.

11.7 Incorrect Judgement: When anticipated services were not located, the cable locator made some assumptions and exercised poor judgement.

23.3 Communication between different organisations not effective: When anticipated utilities were not located, communication with the local utility owner was not undertaken.

- Update RM Ground Disturbance Procedure to include details on:
 - A "minimum requirements" checklist for cable locators to ensure high quality & consistency;
 - Clear guidance on actions to take when borehole clearance depth cannot be reached;
 - Improved ground markings and documentation of identified services, and;
 - Liaison with local asset owners to gain their knowledge / experience of the area;
- Training, communication & implementation of updated RM procedures.
