## Spotlight on Curtis Bay Terminal

### Contractor's

# Spotlight on Curtis Bay Terminal

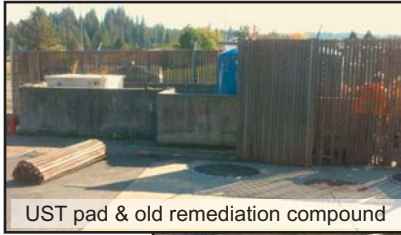
UST pad &amp; old remediation compound

**to the station's USTs**. As can be seen in the photo, the compound and secondary containment structure were immediately adjacent to the UST pad.

An initial plan to remove the 1,000 pound carbon vessels via crane as a non-critical **lift was modified**

**during a Work Risk Assessment Tool (WRAT)** development meeting. In order to minimize the hazard of lifting a load over active UST system components, it was determined that partial demolition of the containment structure could initially occur and the carbon vessels then be removed by use of a Gradall® Telehandler forklift. While removal by the Gradall® was still considered a lift via heavy equipment, the **lift plan elements were reduced and many hazards were eliminated**. This was a clear example of how pre-planning and risk evaluation and mitigation using the WRAT increases safety of workers and reduces the potential of property damage.

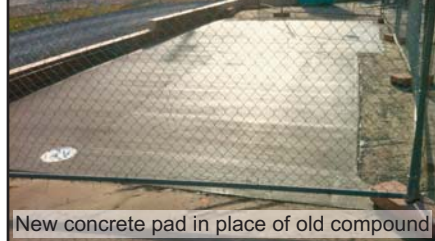
New concrete pad in place of old compound

Broadbent worked with Operations Project Manager Sergio Morescalchi and Cornerstone Environmental Contractors, Inc., to **facilitate system and compound removal**. An early identified complicating factor was the **proximity**

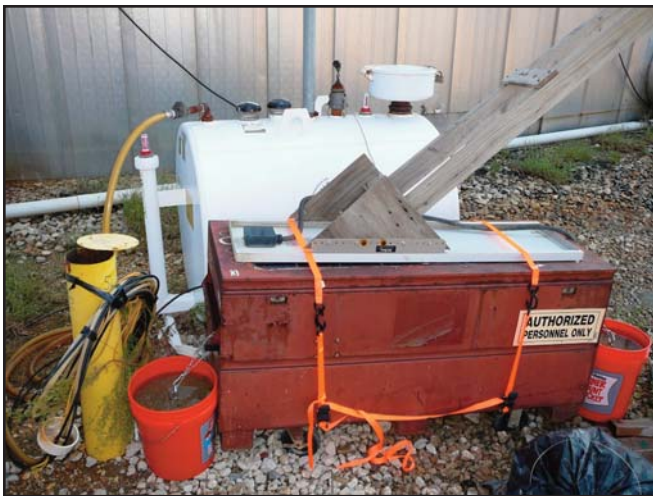
Well, tank, well equipment box & solar panel strapped down

**With just two days notice** to prepare for high winds, electrical outages and a potential 13 foot storm surge covering their waterfront site, the BP Curtis Bay RM team took urgent action to secure the site against potential flood, electrical and release hazards. They did so in an organized manner to **prevent damage and loss of equipment** in the pre- and post-process, adjusting schedules and pulling personnel from other projects to help. **Taking the highest level of precaution**, the team shut down all remediation systems, removed and secured all skimmer pumps and covered all wells with air- and water-tight lids. **To mitigate release and buoyancy hazards** due to flooding, tanks were vacuumed out, moved to higher ground, filled with water to weight them, and secured. Portable electrical boxes and solar panels were also **moved to higher ground and ratcheted down** with straps and concrete "deadmen."

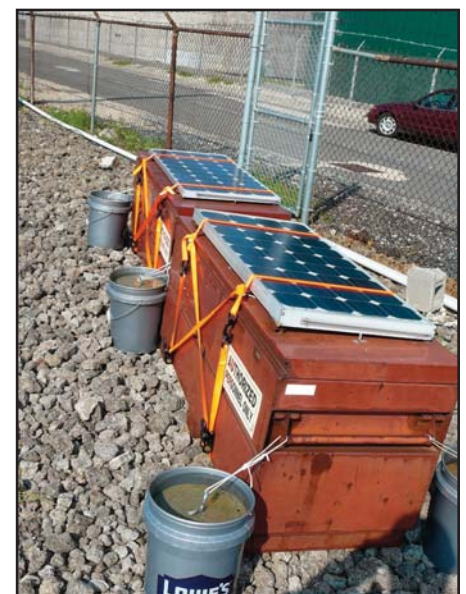
Well boxes moved & stowed on higher ground
