## Spotlight on Curtis Bay Terminal

# Spotlight on Curtis Bay Terminal

## The site

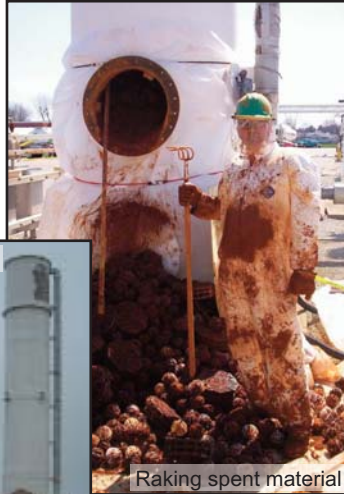
Dayton Terminal air stripper tower

The **BP RM Dayton Terminal** team places great emphasis on **reporting everything**, from blisters to muscle soreness, and this conscientious reporting has **led to safer job procedures**. Each year a 2-man team spends 2 ½ days **raking out 6.95 tons of spent material** from an air stripper tower, and another 2 ½ days in prep and cleanup. While one person rakes the material out of a side opening in the tower, the other rides an aerial lift up and down to whack the tower and free up spent material, and then scoops up the material in a skid steer bucket and moves the material to a roll-off bin. Both jobs require **repetitive motion** and are **ergonomically intense**, and have been performed by the same personnel for a few years, with no injuries or incidents. However, this year, by the end of the 3rd day, the raker reported muscle soreness. **Although performed ergonomically correctly, the wet, cold weather and level of physical effort likely impacted the job to present the new hazard**. After discussing, the team implemented a change in procedure for future work: perform the job one month earlier, when the weather is warmer and dryer, and add a third person to back-up the raker. Says Parsons PM Anna Wieckowski, “This is why we report everything! **Because he felt comfortable reporting, we were able to develop a better procedure** and help prevent this, or worse, from happening again. It’s also a great reminder to consider the **effects of seasonal weather and level of physical effort required when developing WRATs and TSEAs**.” Please consider and share with your teams. – *Special thanks to BP PM Bruno Mancini, Parsons PM Anna Wieckowski, and the Dayton Parsons team!*

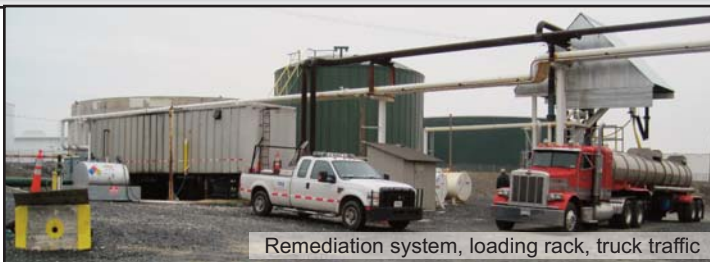
Remediation system, loading rack, truck traffic

BP RM is currently performing remediation on two divested portions of the BP Curtis Bay Terminal (MD), including a **liquid transfer station sitting immediately on the waterfront**, and an asphalt plant. While the asphalt plant may still have several years of remediation efforts remaining, the RM team hopes to be finished with liquid transfer station activities in the next 5 years. The liquid transfer station stores and distributes non-food grade molasses, fertilizers and paraffin, but was formerly an Amoco mixed use facility. The team is **actively recovering LNAPL** utilizing both stationary and portable remediation systems.

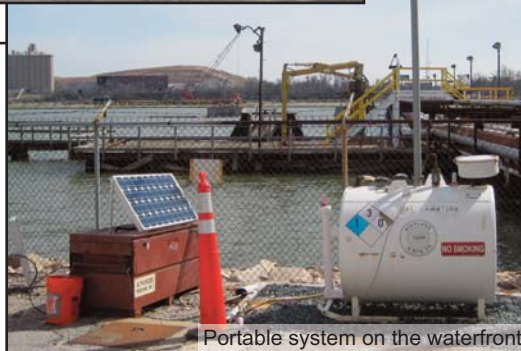
Portable system on the waterfront

The **portable system**, designed for **easy transport** between areas of diminishing and increasing product concentrations, utilizes a Xitech, solar-powered, REM (remote) box, **single station electronic shut off**, and skimmer pumps. The solar panels charge a 12 volt Optima® dry cell battery to power the system, **replacing the original lead acid battery to eliminate acid spill** potential. Nylon product tubing from the wells to the tank inlet manifold is **secondarily contained using petroleum- and UV-resistant transparent tubing** (Superthane®). Concrete filled 5 gallon buckets (dead-men) are **fastened to the box to anchor it** against high winds.

**Skid mounted, double walled, portable product recovery tanks** use Xitech electronic **shut off float switches** to shut off the pump when the tank reaches 7/8 capacity. If weekly O&M determines the tank is at 5/8 full, the skimmer system is manually turned off and a BP certified disposal contractor is contacted. The high-float shut off is attached to the tank with a **safety-lock cam and groove pipefitting, allowing for easy removal** during monthly inspections and testing, and there are **emergency vents** on both the tank and interstitial space, and a **visual pop-up leak detection gauge** on the interstitial space. The **tanks are also grounded**.

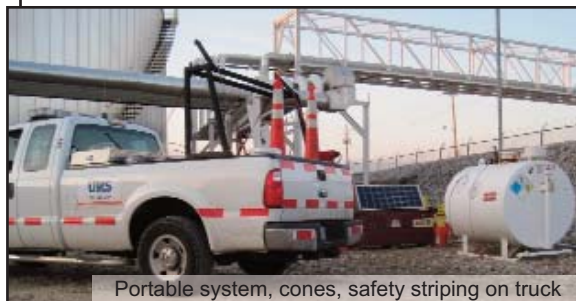
Portable system, cones, safety striping on truck

**Site layout.** The small size and location of the remediation systems on an active third party property mean **visibility concerns** for vehicles and heavy equipment in the immediate vicinity. Traffic cylinders, extra-high cones and barricades are used to delineate the systems, provide more visibility and prevent vehicles from hitting the systems directly. Active tanks, berming and clustered structures provide **limited access** to many portions of the site, requiring special attention to safe driving, parking and backing skills (URS personnel maintain certification in the Smith System Defensive Driving course). Rows of active tanks create cold **wind corridors**, and the URS vehicle provides both transport and shelter.
