Hazards of Auger Drilling

Safety and Health Information Bulletin

SHIB 04-16-2008

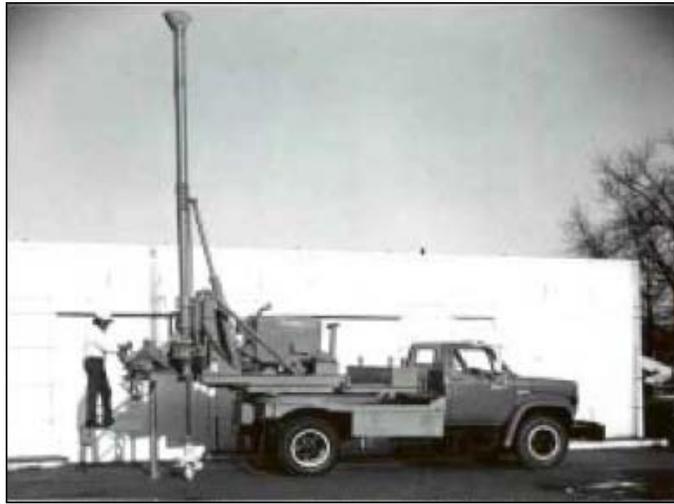
STERLING MODEL, "B-7" Earth Boring Machine with Standard Pole Setter, Hydraulic Winch, 240° Turntable Fore & Aft Platform, Stiffleg. GMC Chassis with Hydraulically Driven Front End Winch.

Figure #1. This is not the truck-mounted auger that was used in this operation, but it is an example of this type of equipment. Notice the operator platform at the rear.

OSHA's Wilkes-Barre, Pennsylvania Area Office investigated a fatality at the site of a newly-constructed administration building. A subcontractor had been hired to install a security fence. On the day of the incident, one post hole was left to be dug. All of the previous post holes had been dug on disturbed construction soil, but the last hole was in a landscaped area covered with mulch. The investigation revealed that the operator did not inspect the area where this last hole was to be dug before drilling and, therefore, was not aware of the landscape fabric beneath the mulch. Consequently, the landscape fabric was not cut to accommodate the 16-inch auger before drilling. Additionally, although the 1961 truck-mounted auger was originally equipped with a platform, it had been removed years before this incident, forcing the operator to stand on the mulch while operating the auger. The accompanying operator's instruction manual did not mention the existence of the platform as a standard piece of equipment for the auger, nor did it refer to it as a safety feature. Newer truck-mounted augers are equipped with a seated operator's control work station mounted on the vehicle. This is a standard configuration for products of this type. Additionally, the accompanying manufacturer's operating manual reflects safe practices for operating the auger from the operator's control station. Although the operator's station removes the operator from the ground, its use does not eliminate the hazard to nearby helpers working on the ground.
