Type of Incident: Property Damage
Business Unit: Buca Retail Remediation Site
Location of Incident: Storage Area
Date/Time: 28/05/09

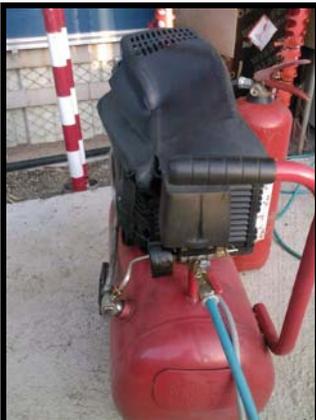
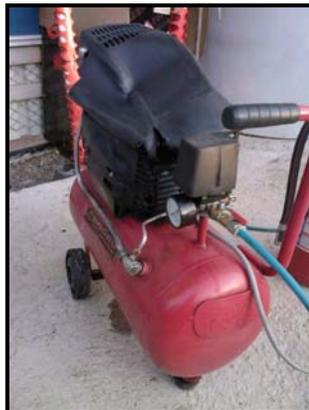
A later examination of the compressor suggested that the heat came from the electric motor, which caused over heating of the power connections and melted the plastic cover. Investigation established that the overheating was due to a failure in the compressor's check valve, which shut down the flow out of the motor. In addition, a thermal overload switch which should have shut down the compressor failed to do so. Electrical current fluctuations were also suspected as a contributing factor, but investigation after the fact found no major concerns.

Actual Outcome: The plastic hood of the compressor melted.

- Compound failure of check valve and thermal overload switch

6.3 Tool malfunction: Check valve and thermal overload switch.

- Based on a review of potential risks following the incident, it has been agreed that this compressor would no longer be used on this site
