## Safety Snapshot # 217

### Lesson # 217 – A Near Miss needs to be reported

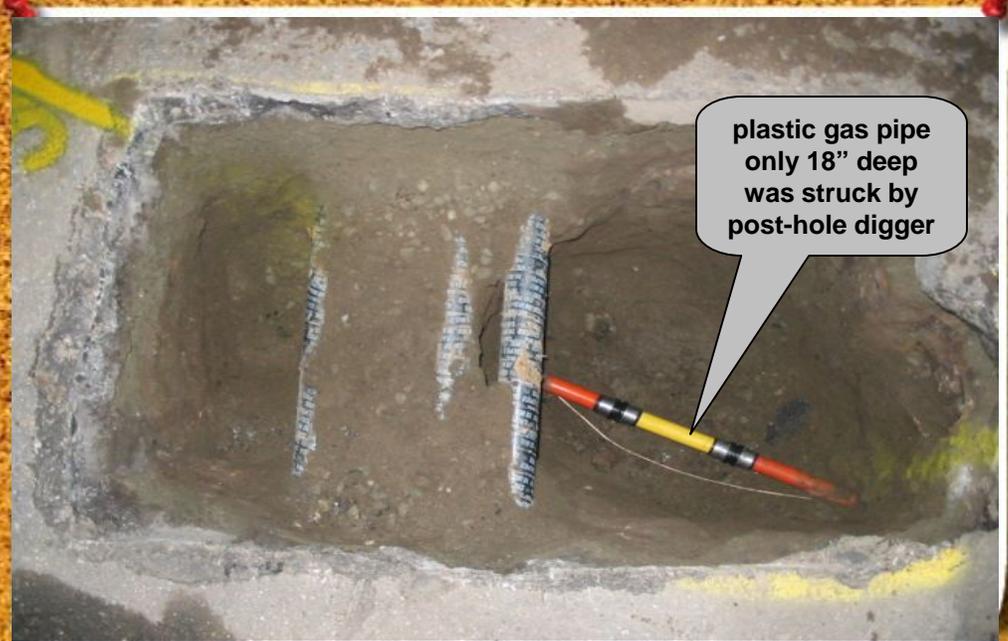
Here is an example of a near miss that could have been a serious incident. Dig Alert was called and marked the underground utilities. A worker used a post-hole digger to dig a shallow hole several feet from the marked-out utilities. Unfortunately, the existing plastic gas line was not located where marked, and was buried only about 18" inches below grade. The worker struck the gas line and notified his supervisor; the job was stopped and the gas company quickly responded and repaired the leaking line. **This near-miss reminds us that before you ever dig at a facility, it is a critical to call Dig Alert to locate underground utility lines, and observe markout zones and use hand digging methods in them.** Striking a utility with a piece of equipment can be a BIG problem! If you are unsure of the exact location of utilities and have to work in close proximity, shut them off to be safe.

By reporting this near-miss, the contractor helps raise our awareness and possibly prevents a utility strike in the future. **Report your near-miss to keep people safe!**
