# Concrete Saw Cutting Incident

## Root Root Analysis

Blade Segment Loss – Damage to Station Building

Active Service Station  
Ventura, California

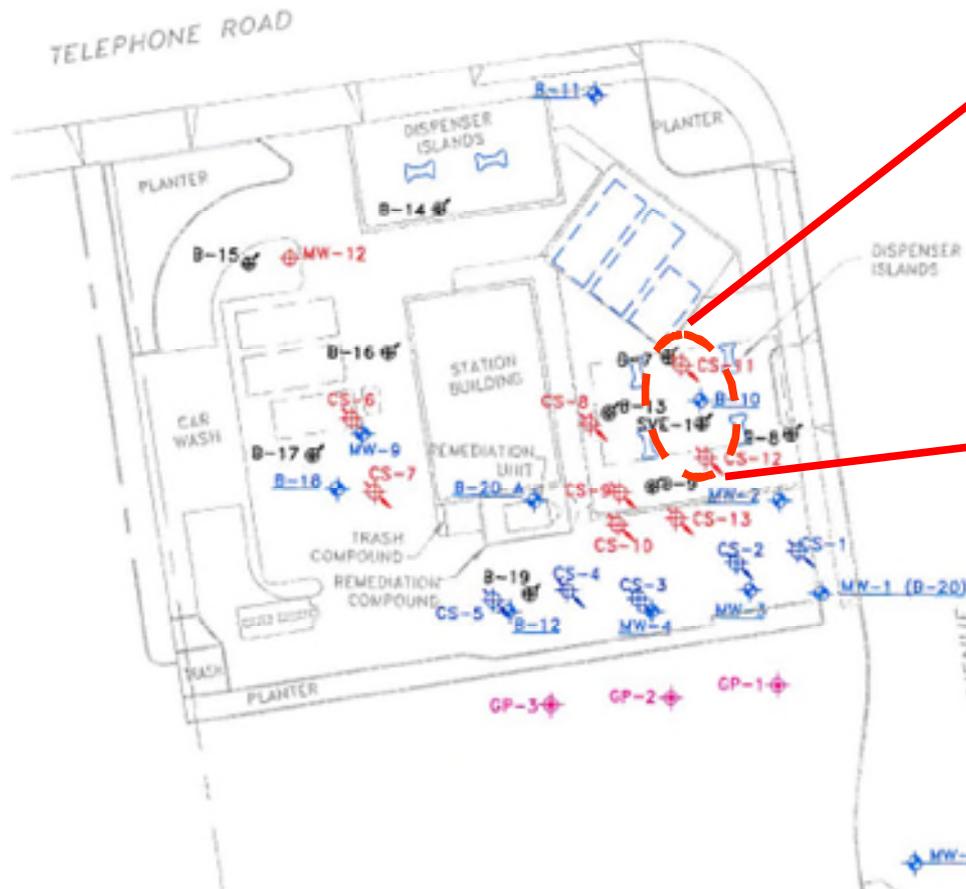
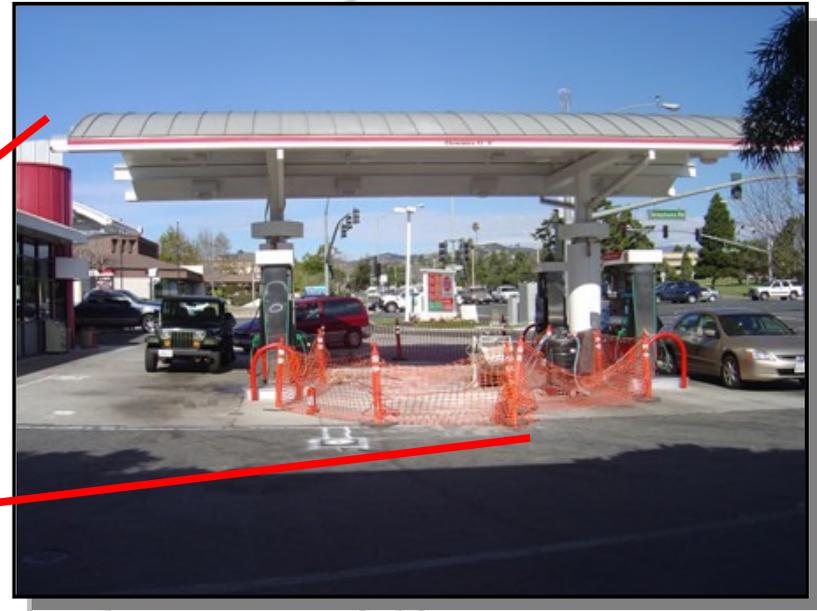
# Site Plan and Work Area Exclusion Zone

Concrete saw-cutting activities were being performed by the construction contractor on January 20, 2009 near new ozone sparge well CS-12 for trenching (within the exclusion zone between two dispenser islands east of the station building).

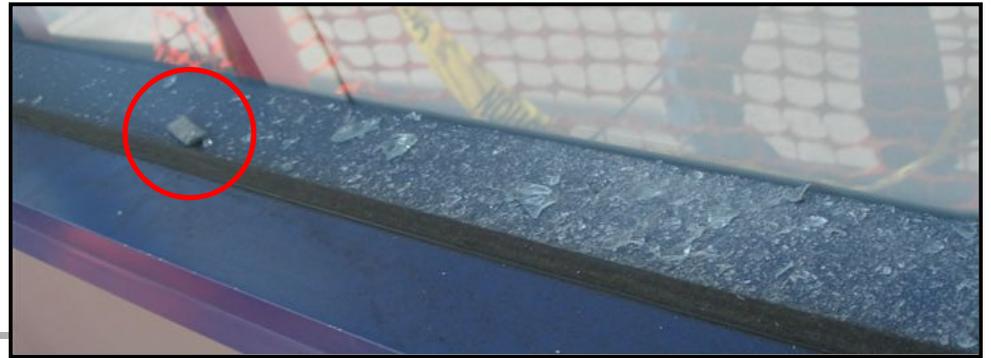
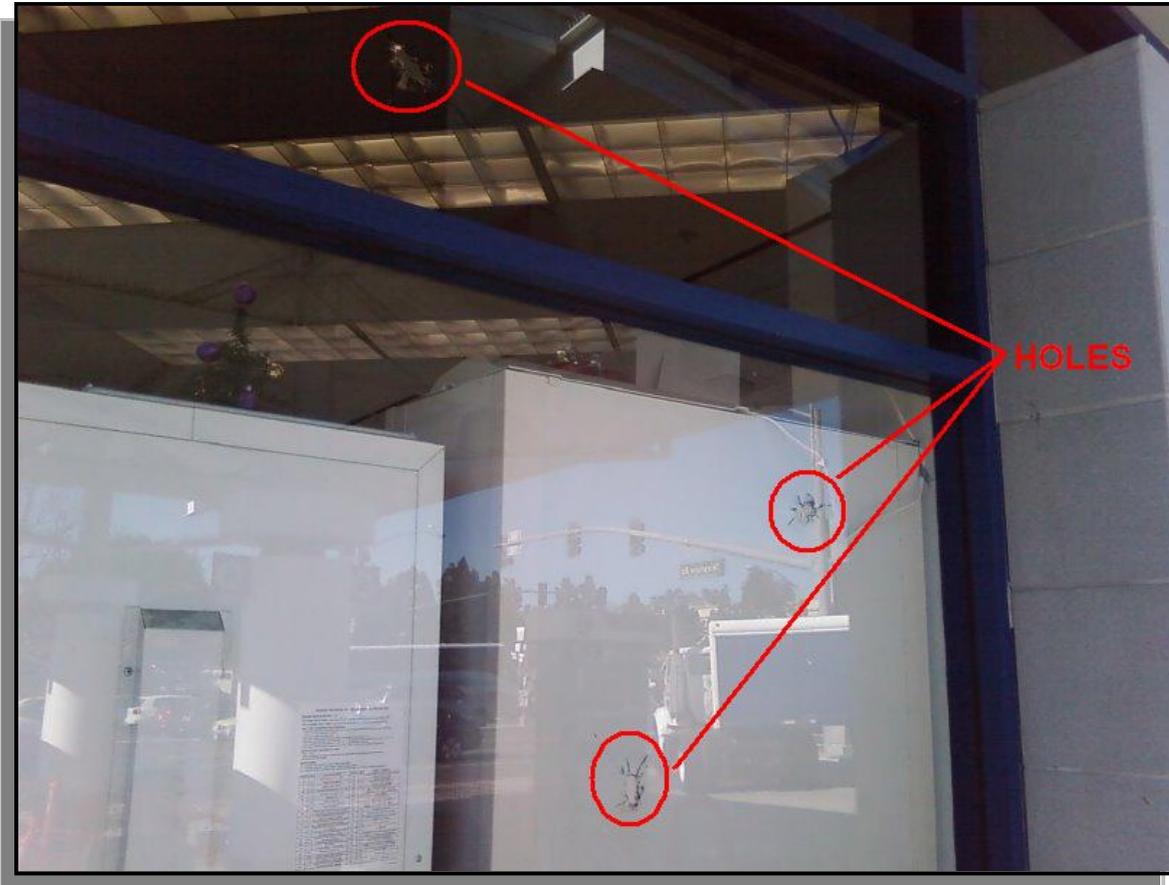
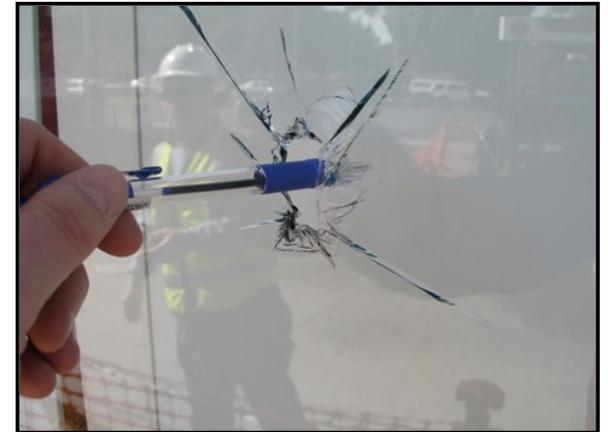
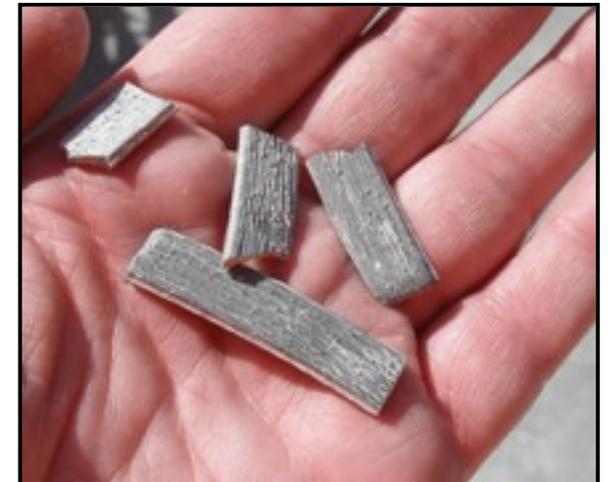
Stop work authority was invoked to evaluate damage, determine what occurred, and the cause of segment loss. It was determined that the broken blade segments had not stayed within the safety guard that envelopes the blade, and had ejected at an angle, impacting the station windows.

- New saw blade was installed.
- Wooden barriers were erected in front of and behind the saw to provide an additional safety barrier should additional segment loss/ejection occur.
- The impacted windows were removed and replaced.

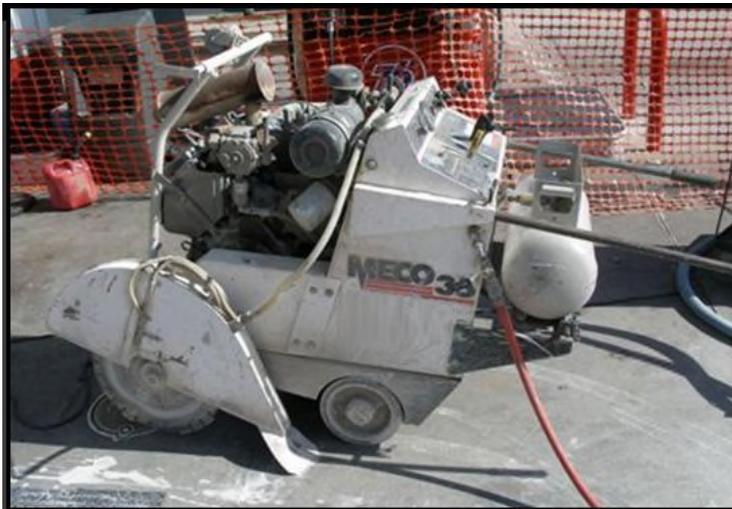
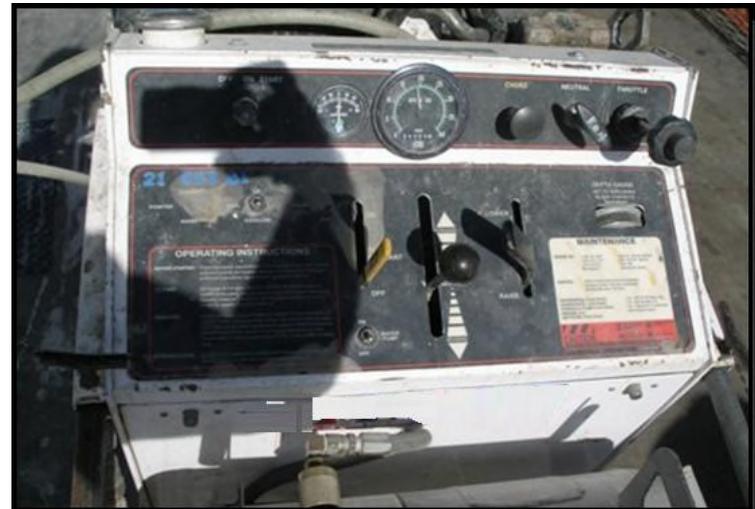
- The operator has five years of saw cutting experience.
- Masterpiece Engineering Company (MECO) 35 horsepower, self-propelled walk behind floor saw:
  - 18-inch diameter wet cutting diamond saw blade (mounted correctly).
  - Saw manufacturer states that 18-inch diameter blade would have approximately 2,800 rotations per minute when operated on saw.
- Coolant water was being used to cool the blade during cutting.
- Total target depth was approximately 4 inches bgs (each individual cut path did not exceed 2 inches in depth).
- Cut lines were marked on a string line with paint for the operator to follow.
- As the saw is designed, the safety guard does not completely cover the blade.

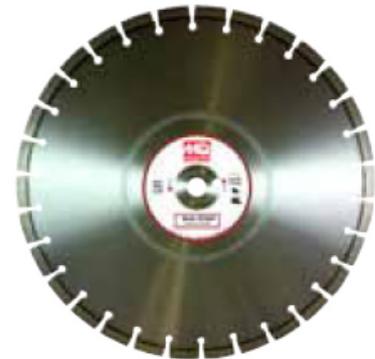
- The blade is designed for cutting asphalt and green concrete
  - The blade is not designed to and is not recommended for cutting cured concrete

- Material being cut was concrete; saw blade was designed to cut asphalt.
- Incorrect blade could have resulted in excessive wear of diamonds and undercutting of core.
