Safety Flash  
SF-2017-037  
IMPACT #9718

## Line of Fire Foot Injury During Crane Deployment

Los Angeles Refinery -Wilmington Receiving, Pumping and Shipping (RP&S)

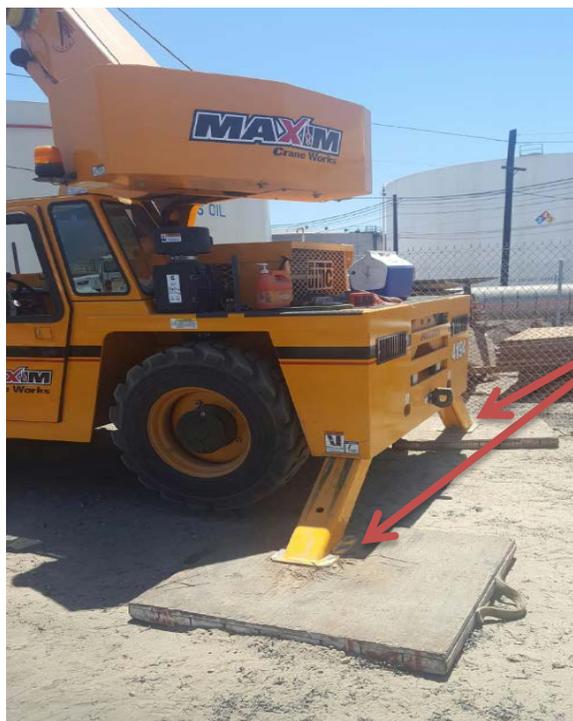
Crane's outriggers already placed on pads

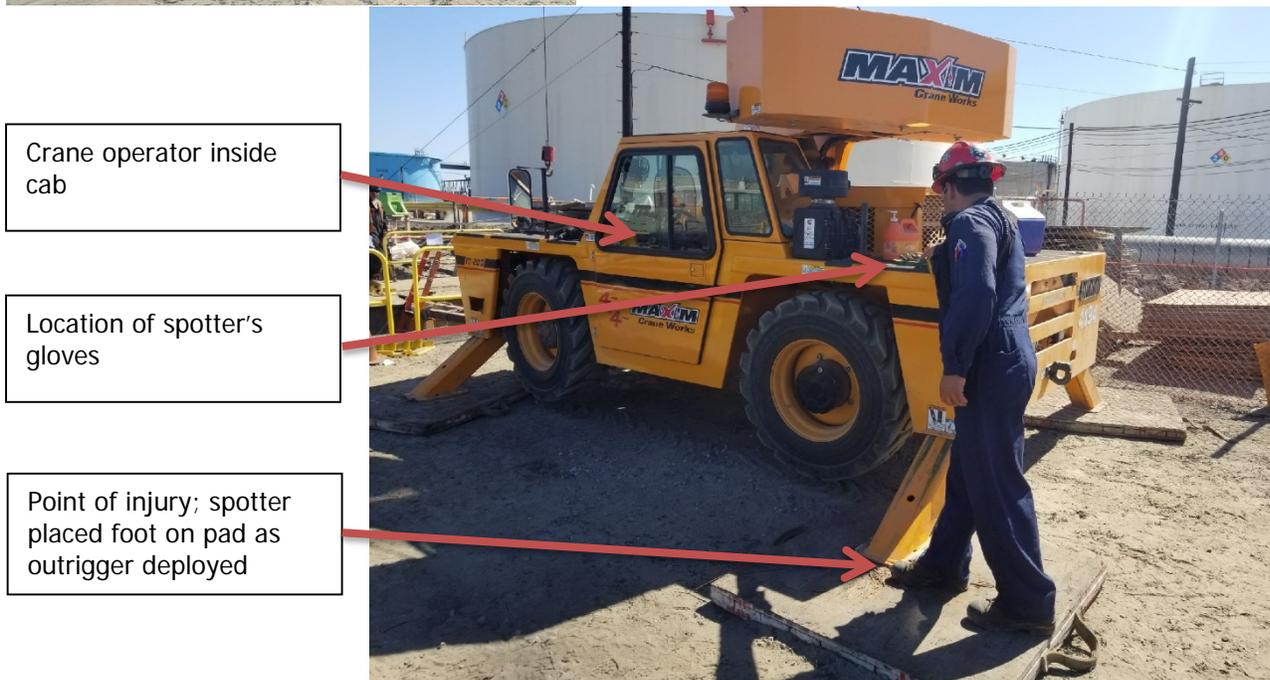
While out of the line of sight of the crane operator, the spotter moved into the line of fire to grab his gloves located on the right rear of the crane carry deck. Moving to grab his gloves placed the spotter's right foot into the line of fire, directly between the wooden pad and a moving outrigger. The resulting foot injury included two broken toes on the right foot, making this incident an OSHA Recordable injury.

Crane operator inside cab

Location of spotter's gloves

Point of injury; spotter placed foot on pad as outrigger deployed

- ✓ Discussions between a crane operator and a designated spotter must include the set-up of the crane, expectations, responsibilities and communications to ensure safe movement of the outriggers.
- ✓ It is important to remain focused on your primary task until it's completed.
- ✓ Before entering into the swing radius of any crane, including the outrigger deployment zones, personnel must directly communicate with the crane operator to gain approval.
